Report Date 11/8/2007

Company B4 U Buy Home & Property Inspections
Address 15466 91A Ave, Surrey, BC, V3R 9W8
Thermographer Dan Lagerstrom

Customer John & Jane Doe
Site Address 17984 61st Ave, Cloverdale, BC
Contact Person

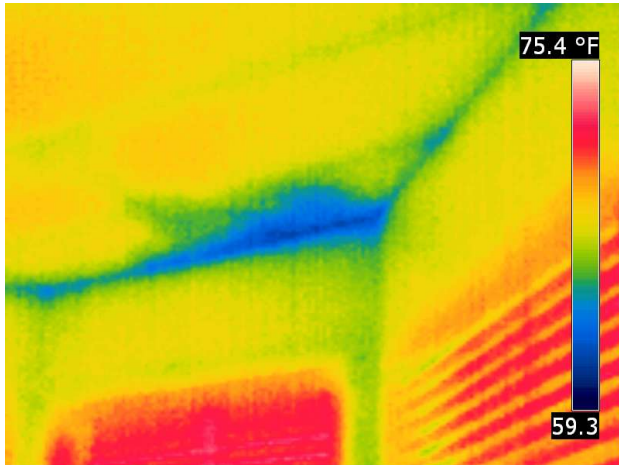
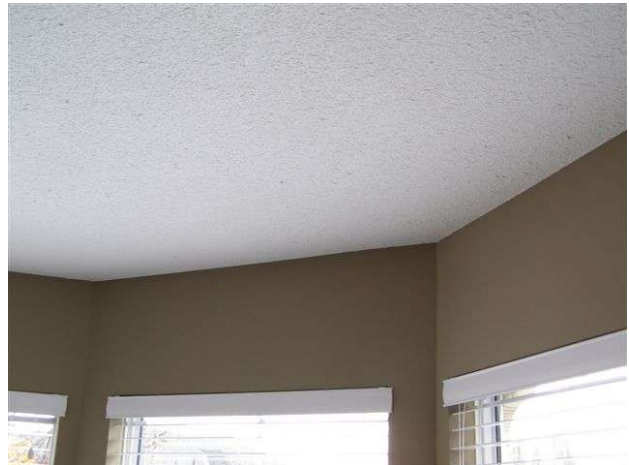
Description
Moisture damage on kitchen ceiling below balcony leak.

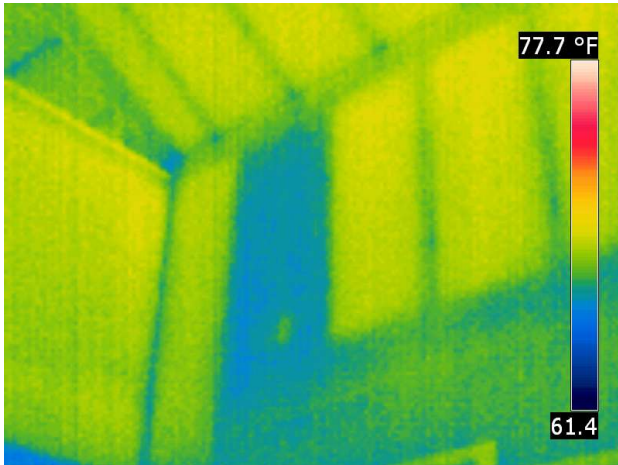
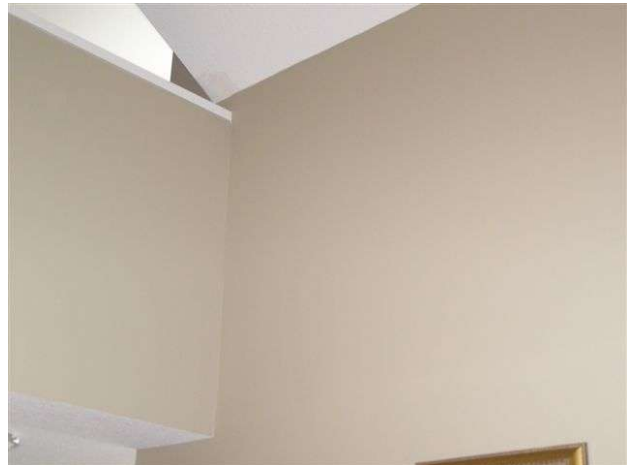
Description
Missing insulation in a wall cavity

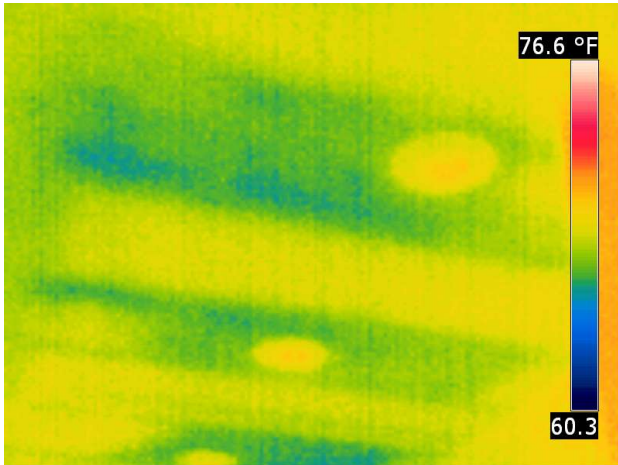
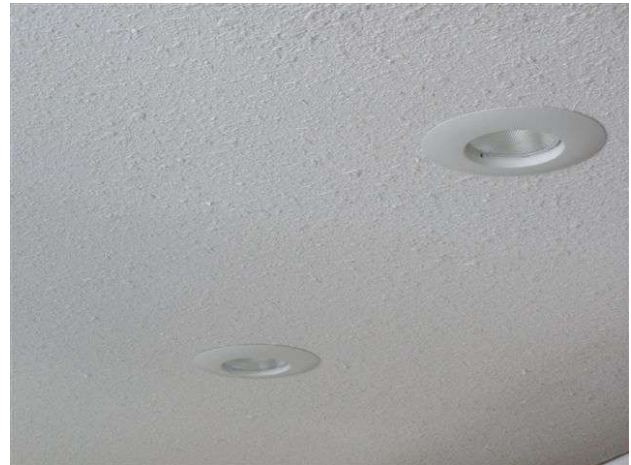
Description
Missing or inadequate insulation in ceiling cavities around potlights.

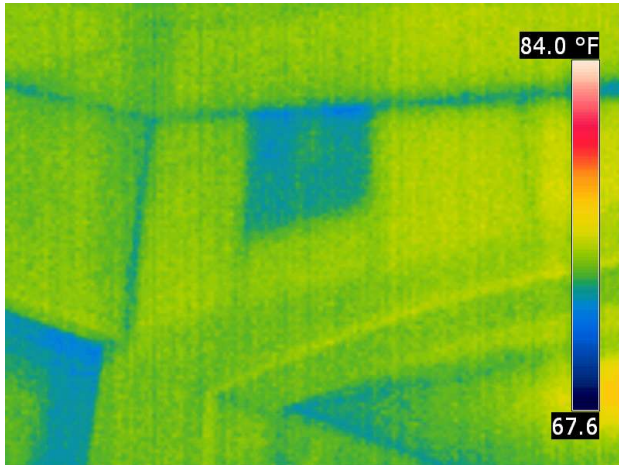
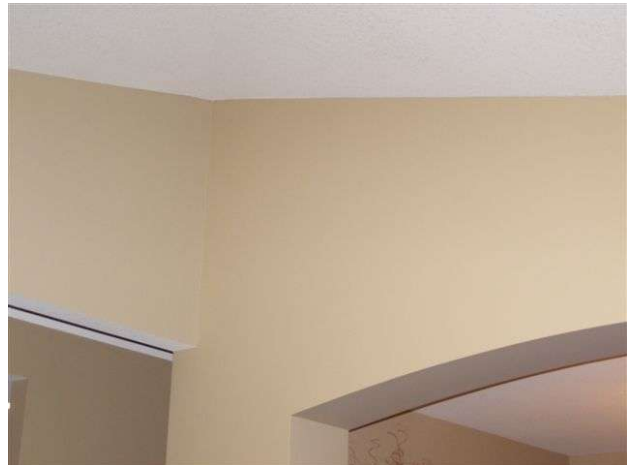
Description
Small section of missing insulation above doorway.

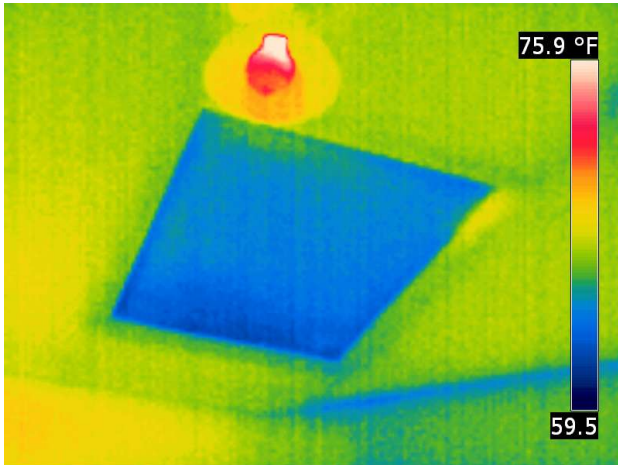
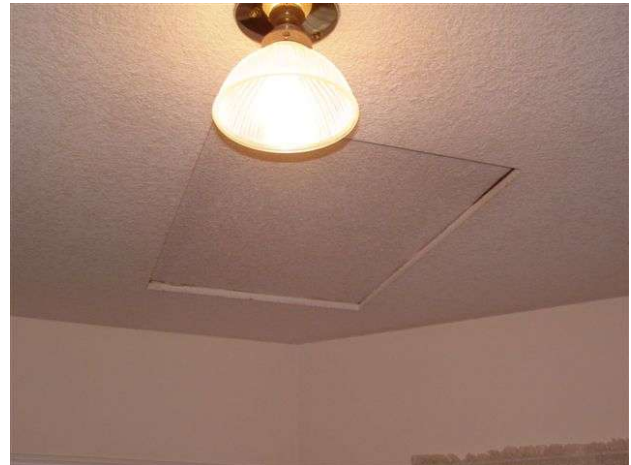
Description
Inadequate insulation on attic access hatch.
